DEPARTMENT OF TRANSPORTATION

Contract #: 04-0120F4Cty: SF/ALA Rte: 80 PM: 13.2/13.9File #: 69.28**WELDING INSPECTION REPORT****Resident Engineer:**Siegenthaler, Peter**Address:** 333 Burma Road**City:** Oakland, CA 94607**Report No:** WIR-023047**Date Inspected:** 28-Mar-2011**Project Name:** SAS Superstructure**OSM Arrival Time:** 700**Prime Contractor:** American Bridge/Fluor Enterprises, a JV**OSM Departure Time:** 1900**Contractor:** Zhenhua Port Machinery Company, Ltd (ZPMC), Changxing Island **Location:** Shanghai, China**CWI Name:** Xu Le Feng**CWI Present:** Yes No**Inspected CWI report:** Yes No N/A**Rod Oven in Use:** Yes No N/A**Electrode to specification:** Yes No N/A**Weld Procedures Followed:** Yes No N/A**Qualified Welders:** Yes No N/A**Verified Joint Fit-up:** Yes No N/A**Approved Drawings:** Yes No N/A**Approved WPS:** Yes No N/A**Delayed / Cancelled:** Yes No N/A**Bridge No:** 34-0006**Component:** OBG Components**Summary of Items Observed:**

WELDING INSPECTION REPORT

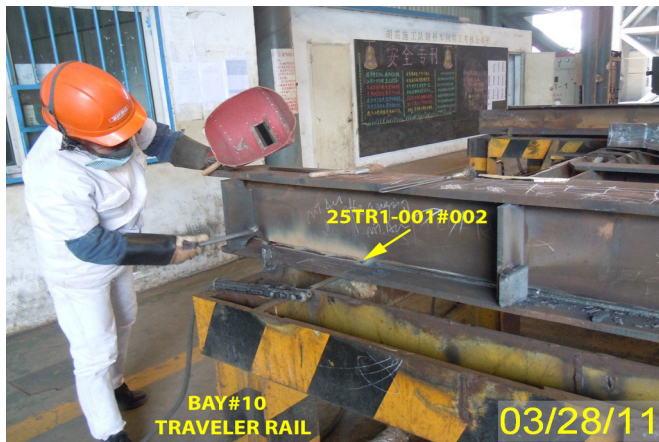
Weld joint #002 located on Traveler Rail 25TR1-001. Welder is identified as 040581. ZPMC Quality Control (QC) Inspector is identified as Jiang Xiao Bo. The welding variables recorded by QC appeared to comply with the WPS-B-P-2212-Tc-U5b. (See attached photo)
